# Performance of Roller Compacted Concrete Pavement in Arkansas

Stacy G. Williams<sup>1</sup>, Ph.D., P.E., Alan Meadors<sup>2</sup>, P.E., Sarah Tamayo<sup>3</sup>, P.E.

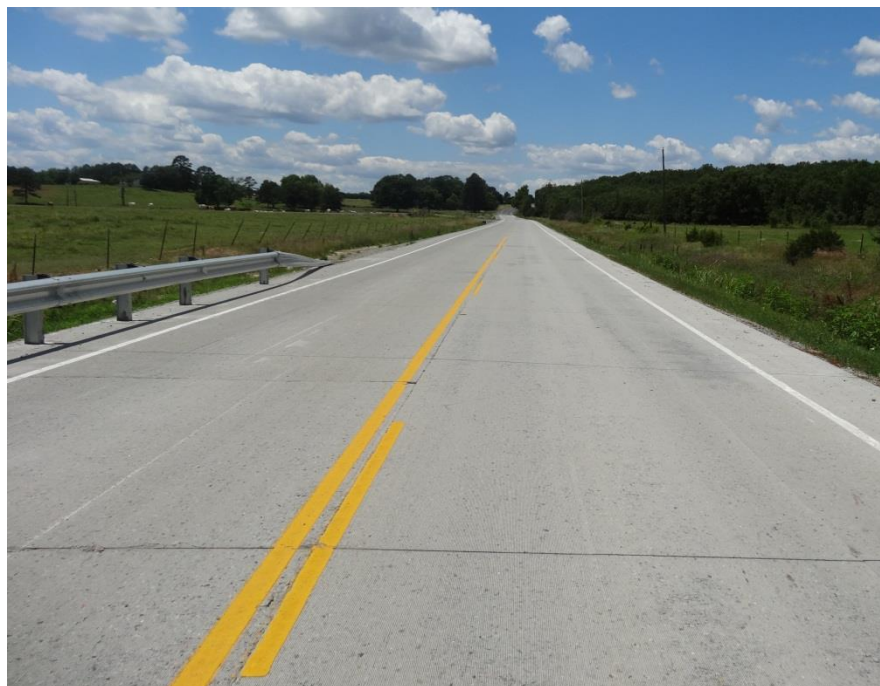
**Section 1 Reconstruction.** Compressive strengths in Section 1 were lower than anticipated after 24 hours, and strengths after 3, 7, and 14 days were also less than desired. Due to the poor strength levels and the success of improvements implemented in Section 2, the contractor elected to remove and replace the majority of Section 1. Compressive strengths were much improved, again confirming the successes resulting from the changes made to the process. A portion of the westbound lane of Section 1 was left in its original condition, allowing for performance comparisons. Diamond grinding was performed on both sections after all paving was completed. The finished product is shown in Figure 1.

**Figure 1. Arkansas Highway 213 RCC Pavement Project**
