## **Field and Laboratory Performance of Cementitious Partial Depth Repair Materials in Cold Climates**

Haithem Soliman, EIT<sup>1</sup> and Ahmed Shalaby, P.Eng.<sup>2</sup>

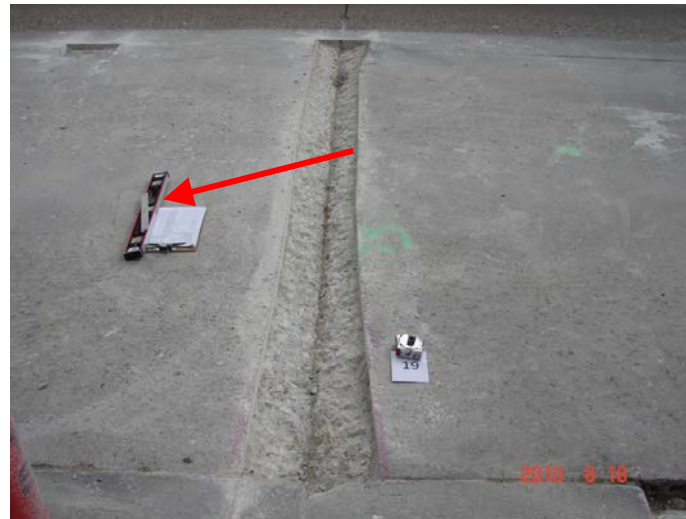
**Figure 3: Typical Cleaned Concrete Surface**

The saw and patch method was used to remove the deteriorated concrete (Soliman et al. 2011). This method consisted of saw cutting the marked edges of the repair to a depth of 40 mm from the pavement surface using a concrete cut-off saw mounted on a cutting cart. Once the repair boundaries were cut, the concrete was removed by a 11.3 kg jackhammer. The concrete was removed by first jackhammering near the center of the repair area and working outwards to the saw-cut. Then the repair surface along the bottom edge of the saw-cut was jackhammered in order to fully expose the vertical surface of the cut. The concrete within the repair area was removed to the bottom of the saw cut or 10 mm below visually sound and clean concrete. The cleaned concrete surface was at a typical 10 to 45 degrees angle from the horizontal as shown in Figure 3.

Once the concrete had been removed, the repair area was thoroughly sandblasted to remove cement dust, dirt, and other debris present. Afterwards, the repair area was air blown to remove any particles left by the sandblasting. This preparation provided a clean surface for the repair material to adhere and bond. The final joint preparation was to mist the surface of the repair area with water immediately before the placement of the repair material. This was done to reduce the tendency of the concrete to attract water from the repair patch and reduce the effectiveness of the patch.
