# LONG TERM PERFORMANCE OF UNCONTROLLED LONGITUDINAL CRACKING AND FAILED LONGITUDINAL JOINTS IN CONTINUOUSLY REINFORCED CONCRETE PAVEMENTS

Eric D. Moody

B. Frank McCullough

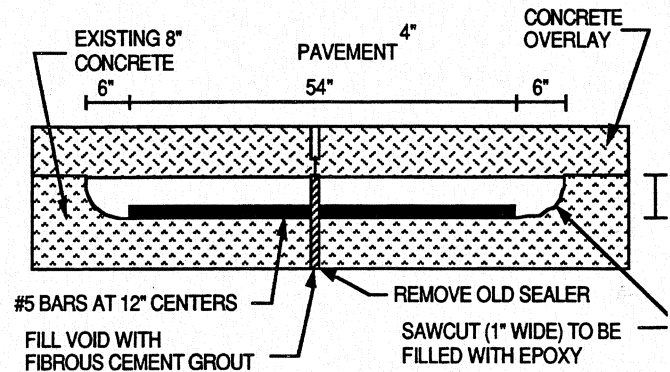
In 1989, the Houston District of the Texas Department of Transportation repaired 3,000 linear feet of longitudinal joints on I-610 in Houston. The objective of this repair is to reestablish load transfer by "stitching" the two sides of the crack together. In this context, stitching refers to cutting 1-inch wide slots at 12-inch centers perpendicular to the joint. These slots were cut to a depth of 3 inches and an overall length of 54 inches, centered on the joint or crack. After the slot was cleaned, a #5 tiebar was epoxied in the slot. A drawing of the repair is shown in Figure 12. Normal surface preparation preceded all repairs. Photos of the repair process are shown in Figures 13 and 14.

FIGURE 12 Cross section of stitching repair.

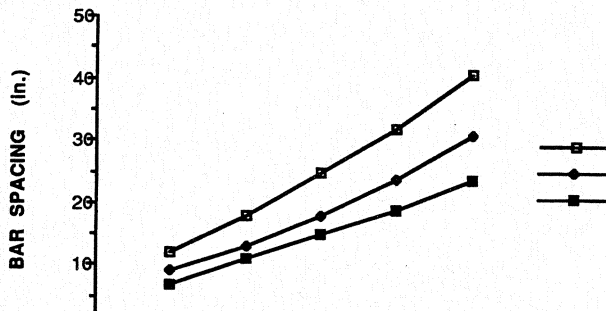
FIGURE 15 Spacing vs. bar size.
