# PERFORMANCE OF CONCRETE PAVEMENT WITH ECONOCRETE BASE

Shie-Shin Wu and Thomas M. Hearne, Jr.

North Carolina Department of Transportation  
Raleigh, North Carolina

**ABSTRACT**  
A three-lane, 16 mile section of I-85 in Randolph and Davidson Counties, North Carolina, was opened to traffic in 1984. The spring following the opening of this section of highway, reddish-brown stains were visible on the concrete shoulders. Water was determined to be flowing under the slabs and blowing out through weak points along the joints.

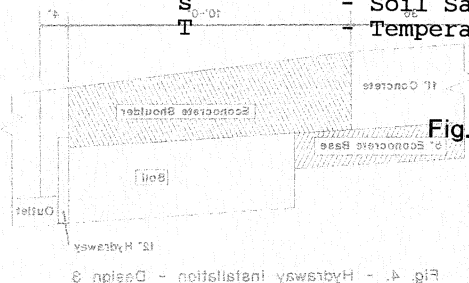
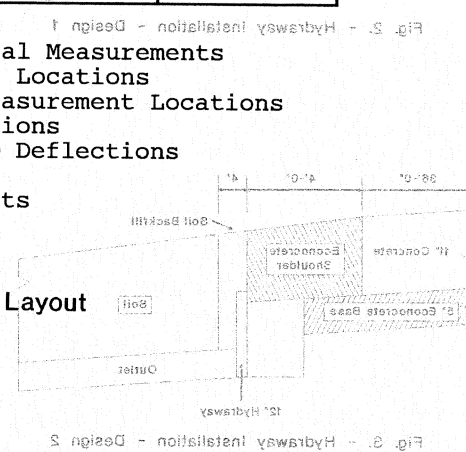
Fig. 5. - I-85 Test Layout

A series of tests were performed near milepost 92 on the southbound lanes of Interstate 85 in April and November 1987. These tests included temperature measurements, horizontal and vertical slab movements, Benkelman Beam and Falling Weight Deflectometer deflections, dowel locations, and determinations of concrete and soil properties. Illustrated in Fig. 5 is the general test layout.

Both Benkelman beam and Falling Weight Deflectometer deflections were recorded at the locations designated in Fig. 5. A couple of points are noteworthy. Firstly, the deflections recorded in November as shown in Table 6 are double those recorded in April and secondly, the magnitude of the deflections change dramatically during the day -- typically varying by a factor of 10. Again these observations are consistent with the curling of the slabs caused by temperature gradients.

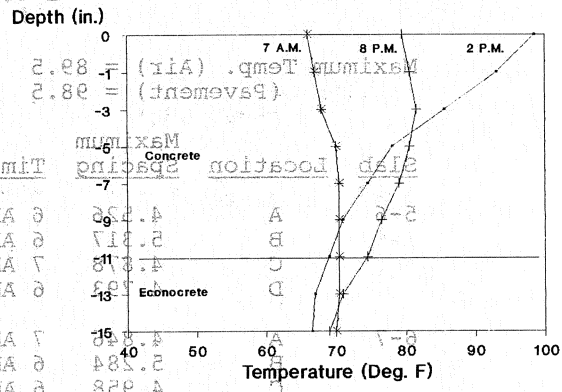
Fig. 6. - Pavement Temperature Distribution  
I-85 SBL MP 92, 4/22-23/87

afternoon, and evening temperature distributions are shown in Figs. 6-8. Note the wide swings in temperature and the steep temperature gradients that can occur near the surface during the mid-afternoon and early morning hours as compared to the relatively minor changes which occur near the base.
