# Inventory & Analysis of Minor Concrete Infrastructure for the City and County of Denver

## Abstract

The City and County of Denver (CCD) and the University of Colorado Denver (UCD) have been involved in cooperative research since 1997. Although a variety of projects have been completed, the main deliverable has been a comprehensive Geographic Information System (GIS) database containing both major and minor infrastructure. Major infrastructure included assets such as bridges and streets, while minor infrastructure includes assets of alleys and street subsystems, which include curbs, gutters, inlets, sidewalks, driveways, crosspans, and curb ramps. This paper presents the equipment and methodology used for the inventory and analysis summary of CCD's concrete curbs, gutter pans, and alleys.

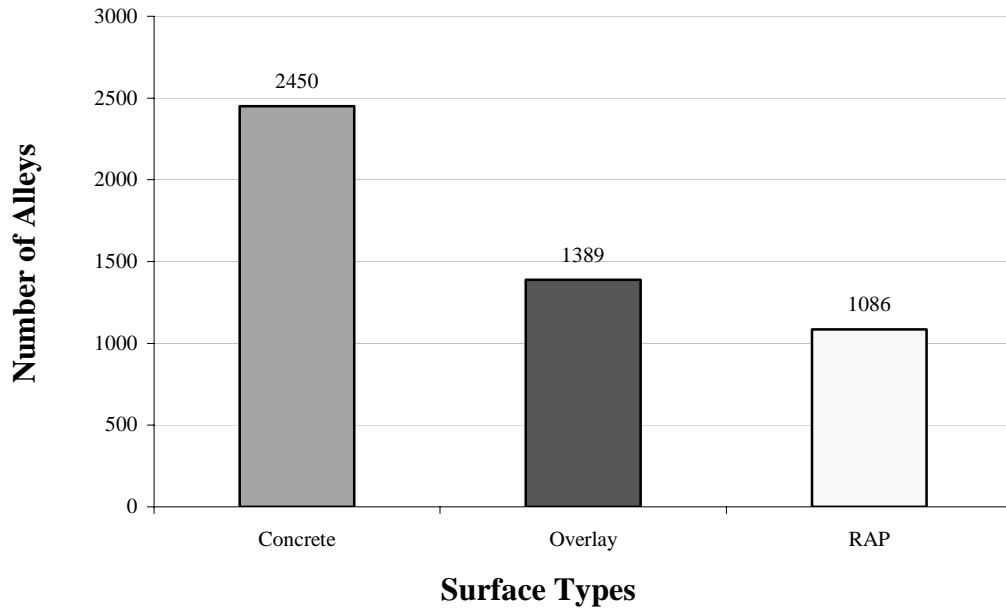
**Figure 1. Alley inventory sorted by surface type.**

One basic unknown prior to this project was an accurate breakdown of the three alley pavement surface types. Inspectors began the inventory just prior to the summer of 2000 and finished around 15 months later. The final count revealed that the city has just over 5,150 alleys that it owns and maintains. The breakdown of these alleys by surface type is illustrated in Figure 1. In general, half of the total inventory consists of concrete alleys and the other half is split between overlay and RAP types. The knowledge of alley pavement surface types and condition will play a crucial role in determination of repair or rehabilitation strategies. Figure 2 shows condition rating index ranges for concrete.

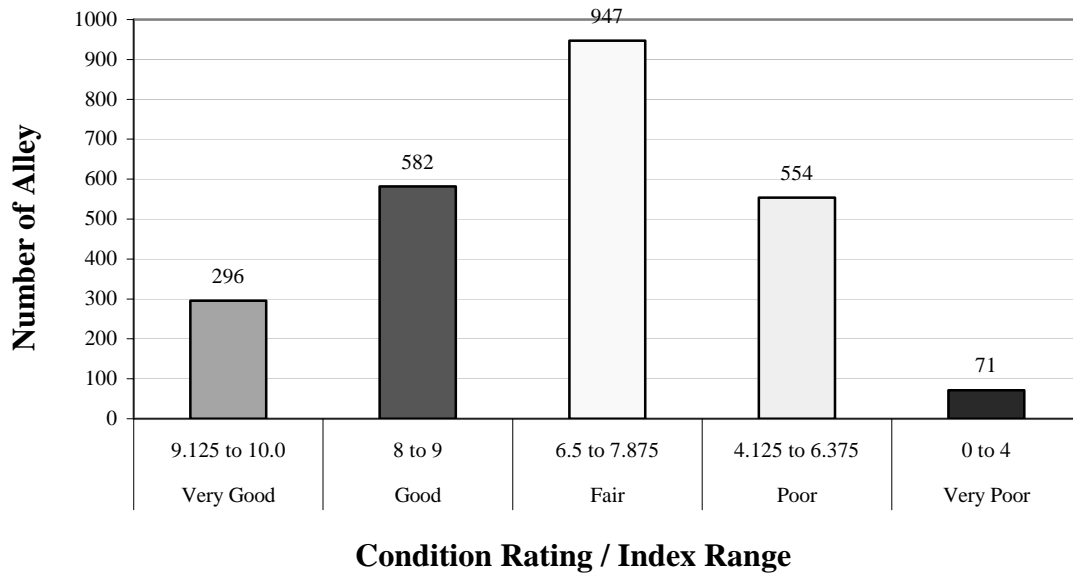
**Figure 2. Condition rating of concrete alleys.**

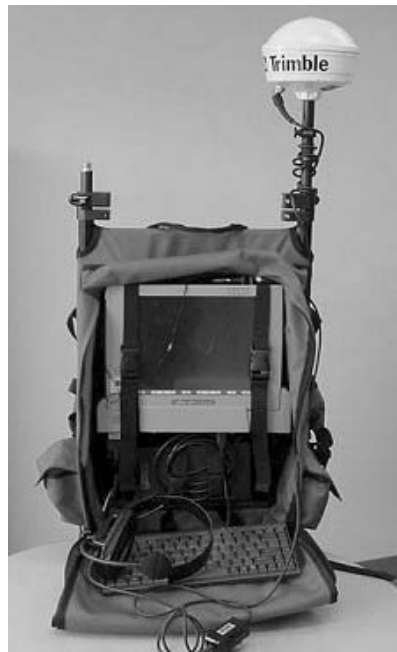
**Figure 4. Vocarta System used by UCD.**

One to three data collector GPS units, as shown in Figure 4, were dispatched regularly to collect CCD street subsystem assets. An inspector physically walks through every curb in the CCD region and is able to collect data only by talking to the computer. The inventory and assessment data is automatically fed into a database that can be downloaded to the GIS system. The equipment consists of a backpack, small computer, GPS receiver, and headset. Using software developed by Datria System Inc. an inspector can call out commands to record the city's asset locations and condition. The voice command software enables the inspector to run the computer without having the need to use a keyboard or mouse. Every time the inspector calls out a command, to verify that the computer acknowledged the right command, the program will speak back what command the computer understood with a computer generated voice.

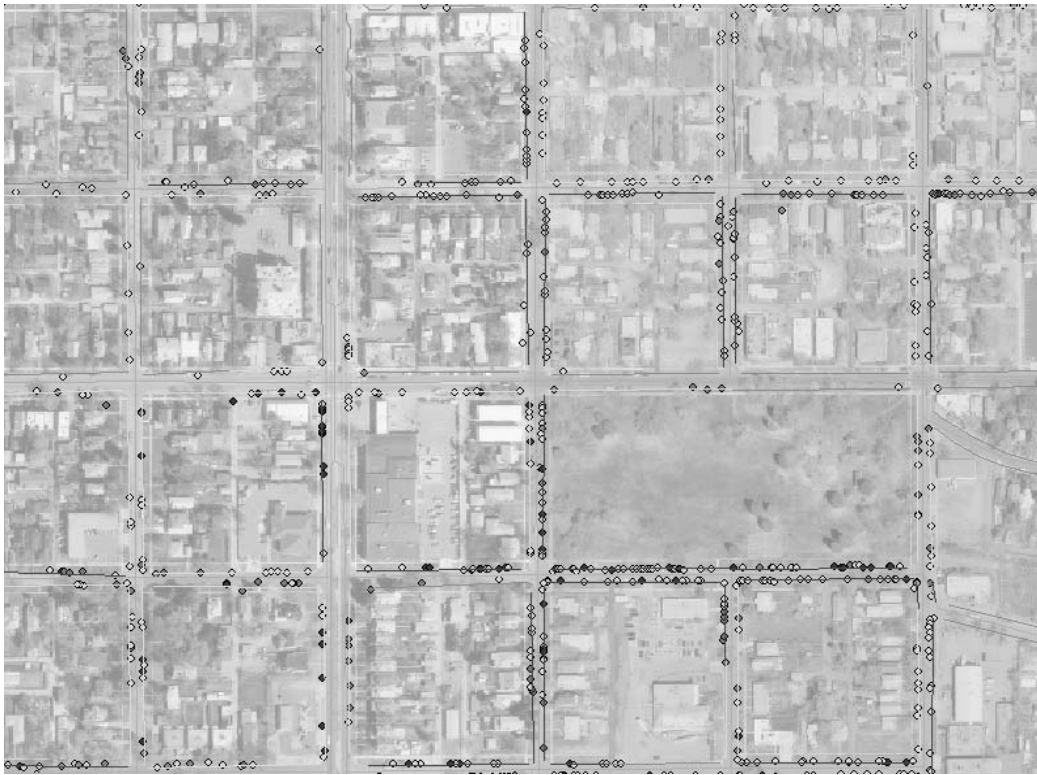
**Figure 6. Distresses on curb with a rating system.**

Using the rating system, these clustered distresses that are very hard to interpret can be transformed into a map as shown in Figure 6. With this map, the CCD would be able to determine which areas need more attention without having to zoom into each curb. This rating system breaks down the curbs into 3 colors, red for poor condition, yellow for medium condition, and green for good condition. Using the ArcMap program, the curbs can be broken down into even more than 3 color rating categories.

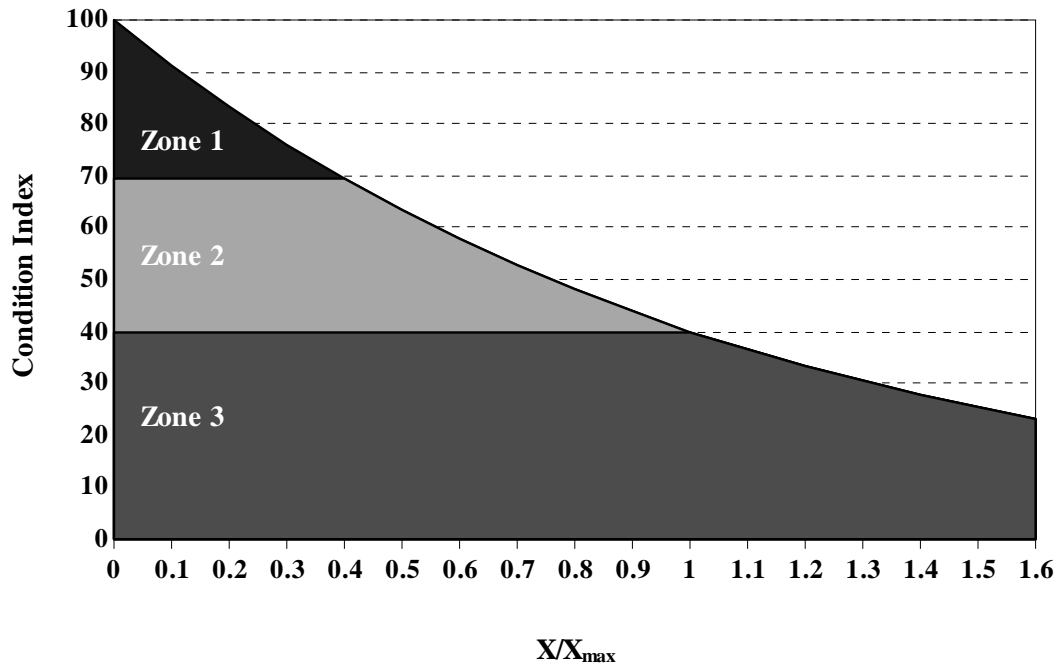
**Figure 7. Condition index as related to  $X$  (a measurement or distress occurrence) /  $X_{max}$  (limiting value of the distress).**

Where  $X_{max}$  is a limiting number of X. In this case, X is the number of distress, where  $X_{max}$  is the maximum number of distress when curb is considered in poor condition and immediate action is required. Therefore, if a curb does not have any distress at all, CI will be equal to 100. On the other hand, when X is equal to  $X_{max}$ , the CI will be equal to 40. Figure 7 illustrates the equation and Table 4 explains each condition index zone.
