# **Design and Construction of a Pervious Concrete Pavement in Ontario, Canada**

## **Abstract**

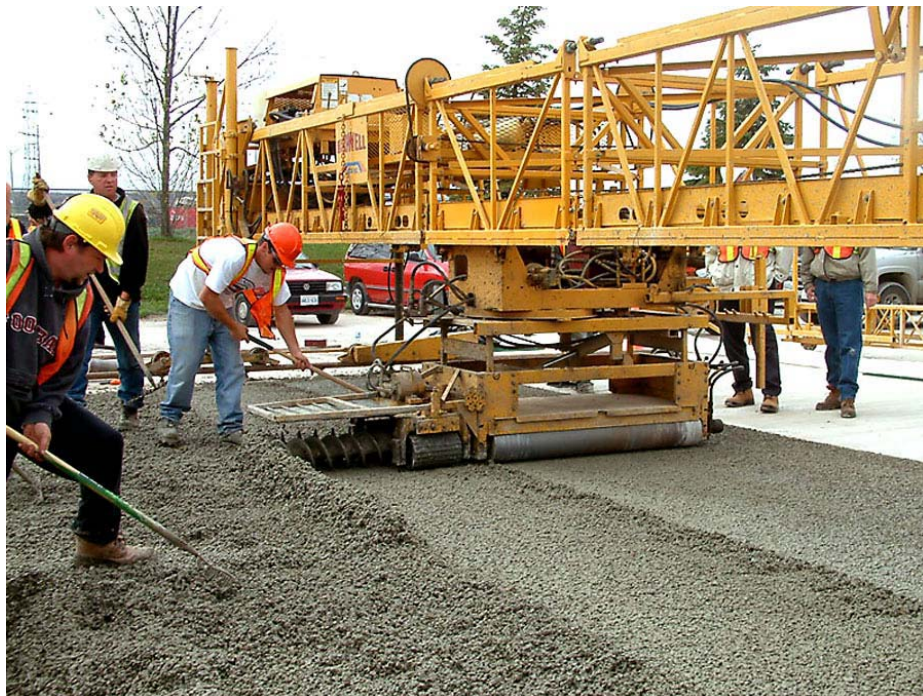
Figure 2. Finishing Equipment

The trial slab was constructed on October 10, 2007 at the concrete supplier's Ready Mix Concrete Plant located in Burlington, Ontario. The contractor opted to use a Bid-Well bridge deck finishing machine as shown in Figure 2, instead of equipment typically used for placement of pervious concrete pavement. The finishing machine was a self-propelled unit with a power screw auger, a vibratory roller, and a rotating cylinder screed. The equipment did not meet the requirements of the contract, which specified that the equipment used for placing, consolidating and finishing the pervious concrete pavement be a vibratory steel screed or steel cylinder screed with integral internal vibration including automatic shut-off,

operating on fixed forms. Another requirement was that following strike-off, the concrete be roller-compacted to the form level using a steel pipe roller spanning the width of the section placed, exerting a vertical pressure of 65 kPa to 205 kPa on the concrete, or alternatively, a hydraulically actuated rotating tube screed. Instead, the contractor proposed to place the pervious concrete slightly higher than the forms and compact it using a steel pipe roller to achieve compaction. However, this was not carried out during construction.

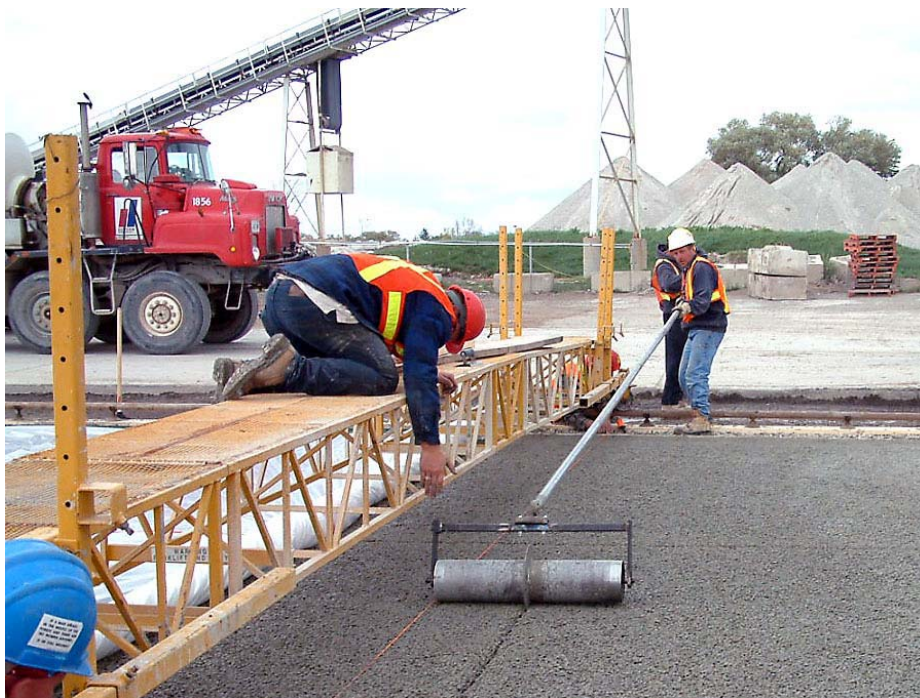
Figure 3. Transverse Joint Rolling (Trial Slab)

Longitudinal and transverse joints were constructed using a steel roller with a bevelled fin as shown in Figure 3. During the jointing process, it was observed that this equipment could not produce clean vertical cuts. Coarse aggregate was plucked up during the operation making it difficult to roll the equipment and to produce clean vertical lines. Also the contractor's decision to place the pervious concrete in 10 metre wide strips with a single longitudinal joint resulted in a wide slab, which created challenges for maneuvering the roller. Another observation from rolling the joints in the plastic concrete was that the process inhibited the timely placement of the plastic moisture barrier for curing.

12. Installation of joints in the plastic concrete using a steel roller should be eliminated. Dry saw-cutting of joints provides an acceptable process for installing joints.

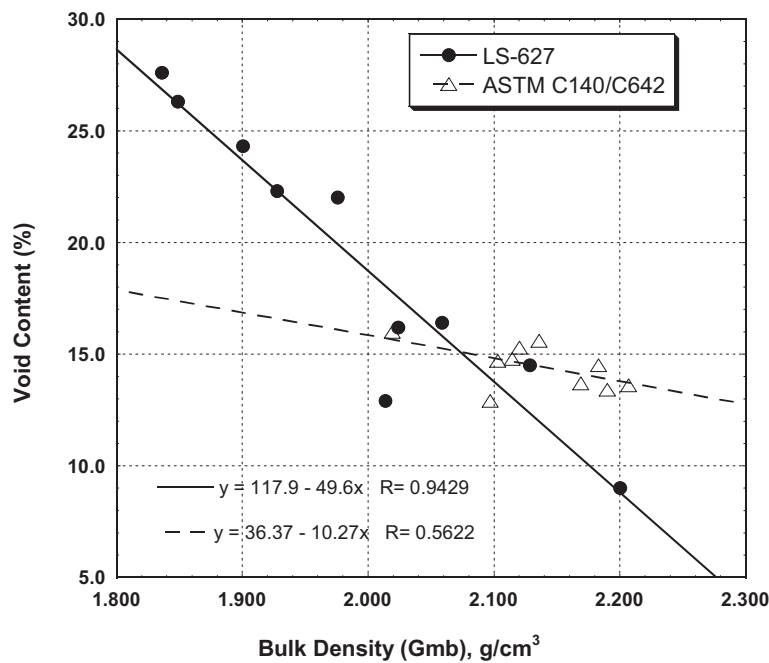
The original specification for the project referenced ASTM C140 paragraph 8.3.1, as the procedure for obtaining saturated and oven dry weights of each specimen. For this procedure, as-received cores were weighed and submerged in water for 24 hours. Each specimen was then weighed in water to obtain the immersed weight ( $W_i$ ). Specimens were then removed and allowed to drain for 1 minute before obtaining the surface dry saturated weight ( $W_s$ ). An oven dry weight ( $W_d$ ) was then obtained after drying to constant mass. Bulk density of the core ( $\text{g/cm}^3$ ) was calculated as follows:  $G_{mb} = [W_d / (W_s - W_i)]$ . Further to this, calculations from ASTM C642 were applied to determine void content and apparent density ( $G_{mm}$ ). ASTM C642 was not included in the specification documents, but was applied later as a means of using data from the 24 h submersion conducted in ASTM C140. Results are shown in Figure 4.

A second method for determining bulk density and void content, MTO test method LS-627 was completed on the same permeable concrete cores as tested under ASTM C140. LS-627 uses equipment borrowed from the Iowa Pore Index Test, which consists of a modified concrete air meter so as to obtain information on aggregate pore size distribution as it relates to freeze-thaw durability and D-line cracking of concrete pavements (Myers 1980). The apparatus allows for the direct measurement of water volume required to fill the open, permeable pores in a pervious concrete core, thus allowing the porosity (void content) of the test specimen to be determined. Also the core ends were trimmed by saw cutting to obtain bulk volume by direct measurement of the cores' height and diameter. The sample was then oven dried to obtain its dry mass. These values were used in subsequent calculations for bulk density and apparent density. For this procedure, the prepared core is placed in the Pore Index apparatus, which is filled with water up to a predetermined level. The system is then pressurized to increase the level of saturation of the permeable pores. The porosity ( $n$ ) of the specimen is calculated as follows with test results shown in Figure 4:

Figure 4. Comparison of MTO LS-627 and ASTM C140/C642 Test Results for Bulk Density and Void Content for Pervious Concrete

The two alternative methods, direct porosity and vacuum sealing proved much more reliable. Both methods reveal the fundamental relationship between the bulk density and porosity. However, differences between the two data sets are

apparent. LS-627 determined much lower porosities, and slightly higher densities, which is most likely a result of incomplete saturation of the sample due to incompressibility of entrapped air within the inner pores of the specimen. Saturation under vacuum conditions is a much more effective method of ensuring all permeable pores of the specimen have been filled with water.

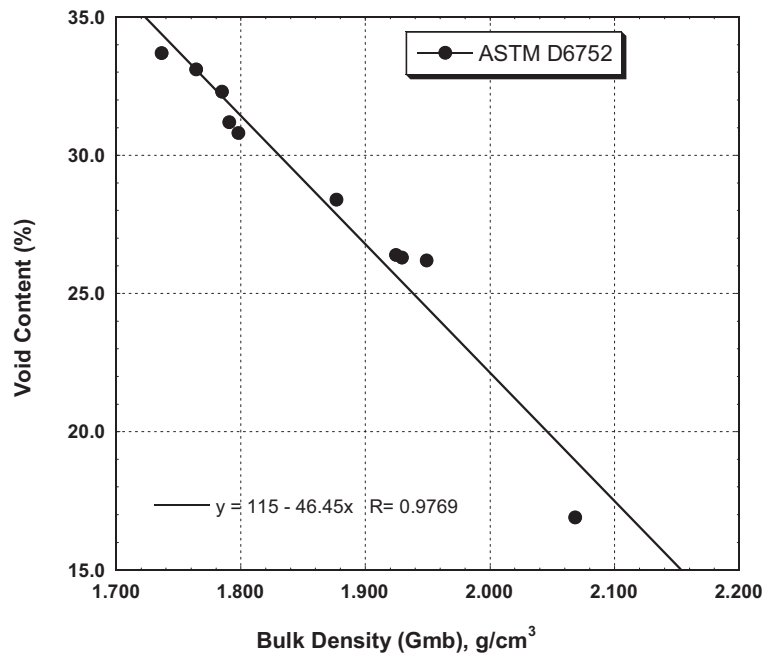
The third test method for determining porosity of the cores samples utilized the existing technology of the CoreLok® system that uses a 1.25 hp vacuum pump and specially design plastic polymer bag to seal samples while they are under near absolute vacuum. This apparatus was specifically designed to provide an accurate method for measuring densities of open, permeable materials and has been incorporated into ASTM procedures ASTM D6857 and ASTM D6752 for bituminous paving mixtures. Methods for determining sample porosity followed those given in the CoreLok® Operator's Guide. For this procedure, oven dried specimens are weighed in air, vacuum sealed and submerged in water. The mass of the submerged sample is recorded to obtain the bulk volume (including voids). The polymer bag is then opened under water to allow the sample to saturate. Since the sample is originally under vacuum, a high degree of saturation is achieved. Once the saturation is complete, it is weighed once more, thus obtaining a measurement of the void content and apparent density of the specimen. Test results are shown in Figure 5 and Figure 6.

Figure 5. Plot of Void Content and Bulk Density of Pervious Concrete as Determined Using Vacuum Sealing Method ASTM D6752

Of the three test methods, both MTO LS-627 and the CoreLok® apparatus (i.e. ASTM D6752/D6857), gave consistent results and would be more effective as a specification than ASTM C140. Test results compared very well with actual sample conditions and confirmed the range in expected values. Some specimens clearly lacked sufficient voids while others were openly porous. Acceptance requirements would vary, depending on which method would be included in the project specifications. Specific requirements should be correlated with field performance tests.

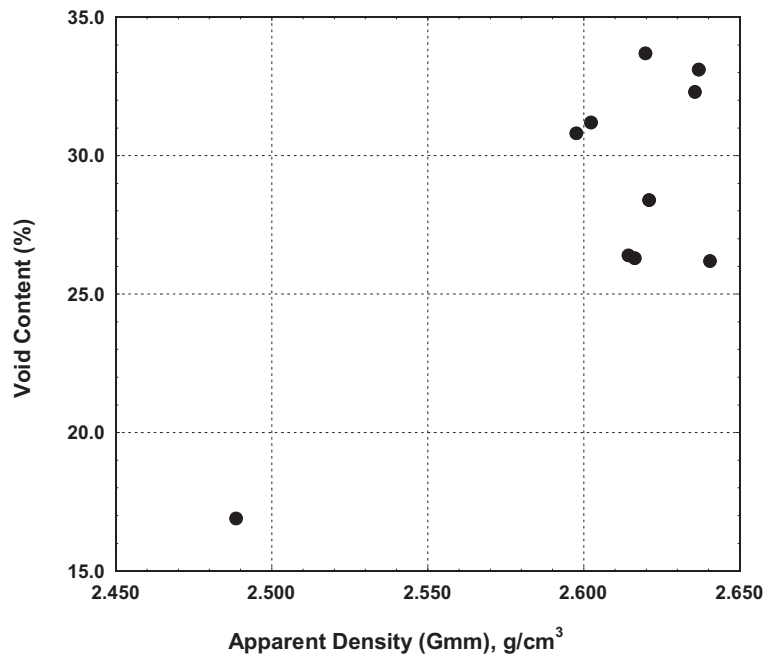
Figure 6. Plot of Void Content and Apparent Density of Pervious Concrete as Determined Using Vacuum Sealing Method ASTM D6857

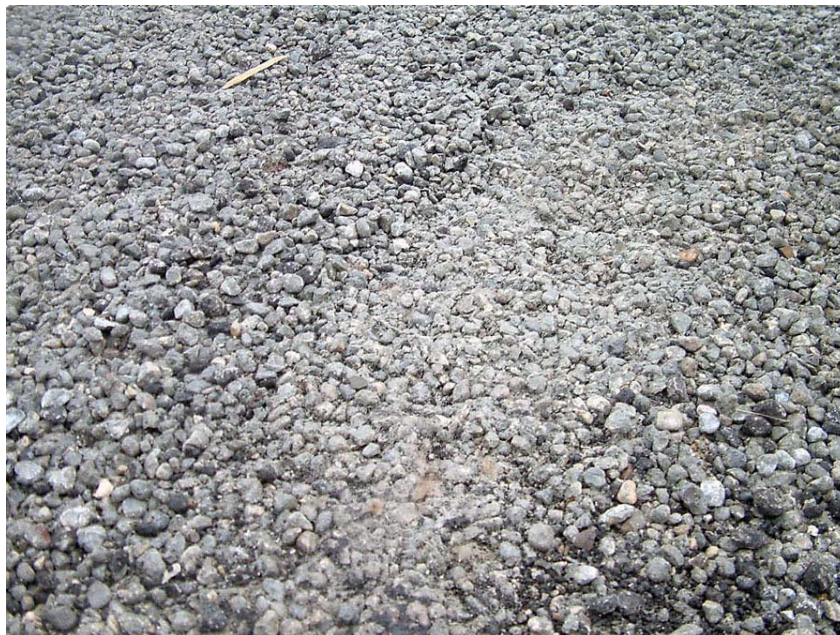
A post construction inspection of the commuter parking lot was carried out on January 4, 2008. The pervious concrete in Sections 1, 2, and 3 was exhibiting raveling throughout with the most severe raveling occurring in Section 2. The northern part of the parking lot in each of the three sections had a few loose aggregates on the surface. Progressing southerly towards the entrance area, the amount of loose aggregate increased. The most severe areas were located in the traveled portions of the parking lot especially where vehicles are turning into the parking spots as shown in Figure 7. In the most severely raveled areas, joints are

difficult to identify. Section 4, which was constructed using a Razorback, did not exhibit any raveling. The surface appeared to be consistent throughout, with some areas not meeting the surface tolerance. Contamination was evident in some areas of the parking lot; mainly from sawdust, granular, asphalt and oil spills.

Figure 7. Areas of Severe Raveling

7. Compaction of the pervious pavement is required through the use of a steel pipe roller. This will reduce the occurrence of surface ravelling.
8. Bridge deck finishing machines should not be used without a separate compaction operation.
