# **A Review and Discussion of Current Developments Involving Bonded Concrete Overlays of Airfield Pavements**

Peter M. Semen<sup>\*</sup> and Raymond S. Rollings<sup>†</sup>

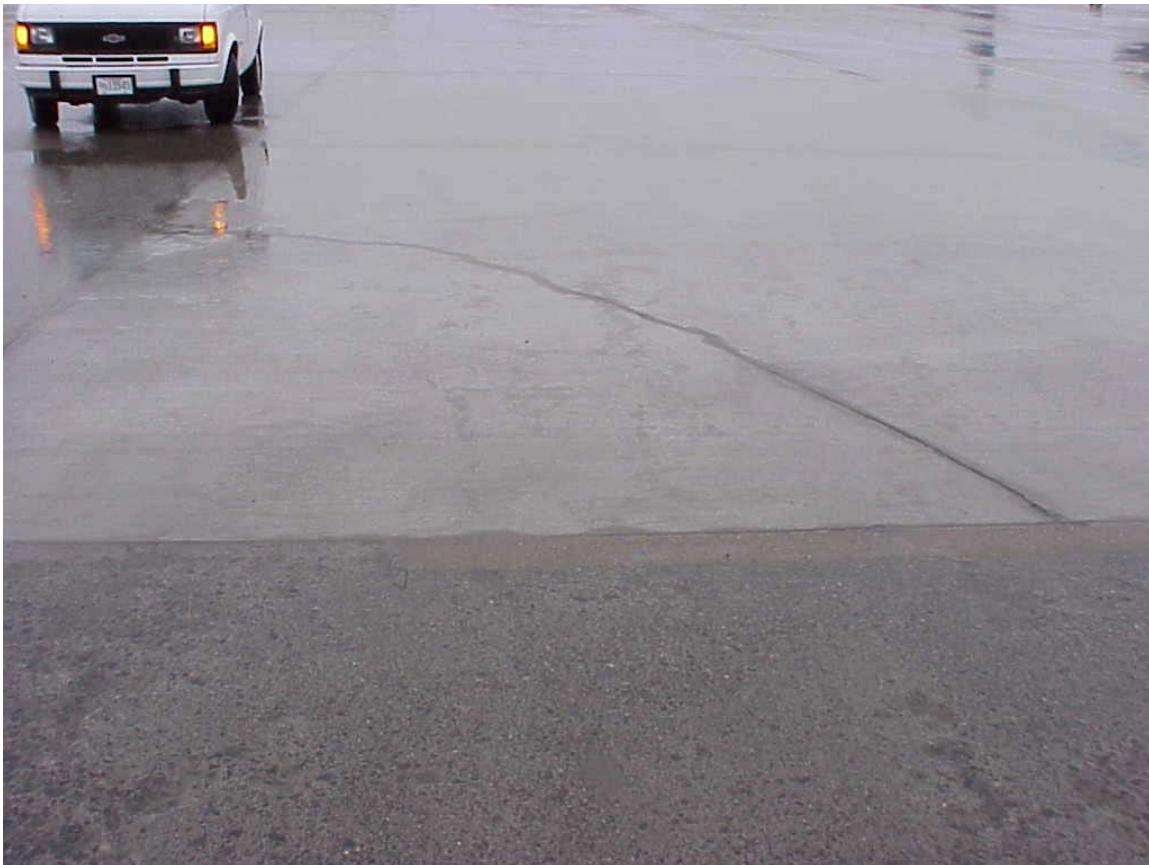
**Figure 1. Corner break in concrete overlay due to bond failure at Fairchild AFB.**

been successful to-date,<sup>‡</sup> their use is limited to correcting functional surface deficiencies of a structurally adequate pavement in good condition other than the surface problems. The cause for the current reassessment was an extensive BCO failure at Fairchild Air Force Base, WA in 1998 which resulted in widespread corner breaks and cracking, ultimately requiring replacement of a significant percentage of the overlay repairs (Figure 1). An Engineering Technical Letter (ETL) on this topic is currently under development and will be published by the Air Force Civil Engineer Support Agency (AFCESA). The authors' intent here is to provide a discussion of BCO-related issues which will form the basis for updating existing criteria.
